ESTIMATION OF COSTS TO PERFORM CLEANUP AT THE  
ASARCO EL PASO SMELTER  
ON BEHALF OF  
THE TEXAS COMMISSION ON ENVIRONMENTAL QUALITY

James Shih-Hong Sher, P.E.  
Texas Commission on Environmental Quality

February 2009

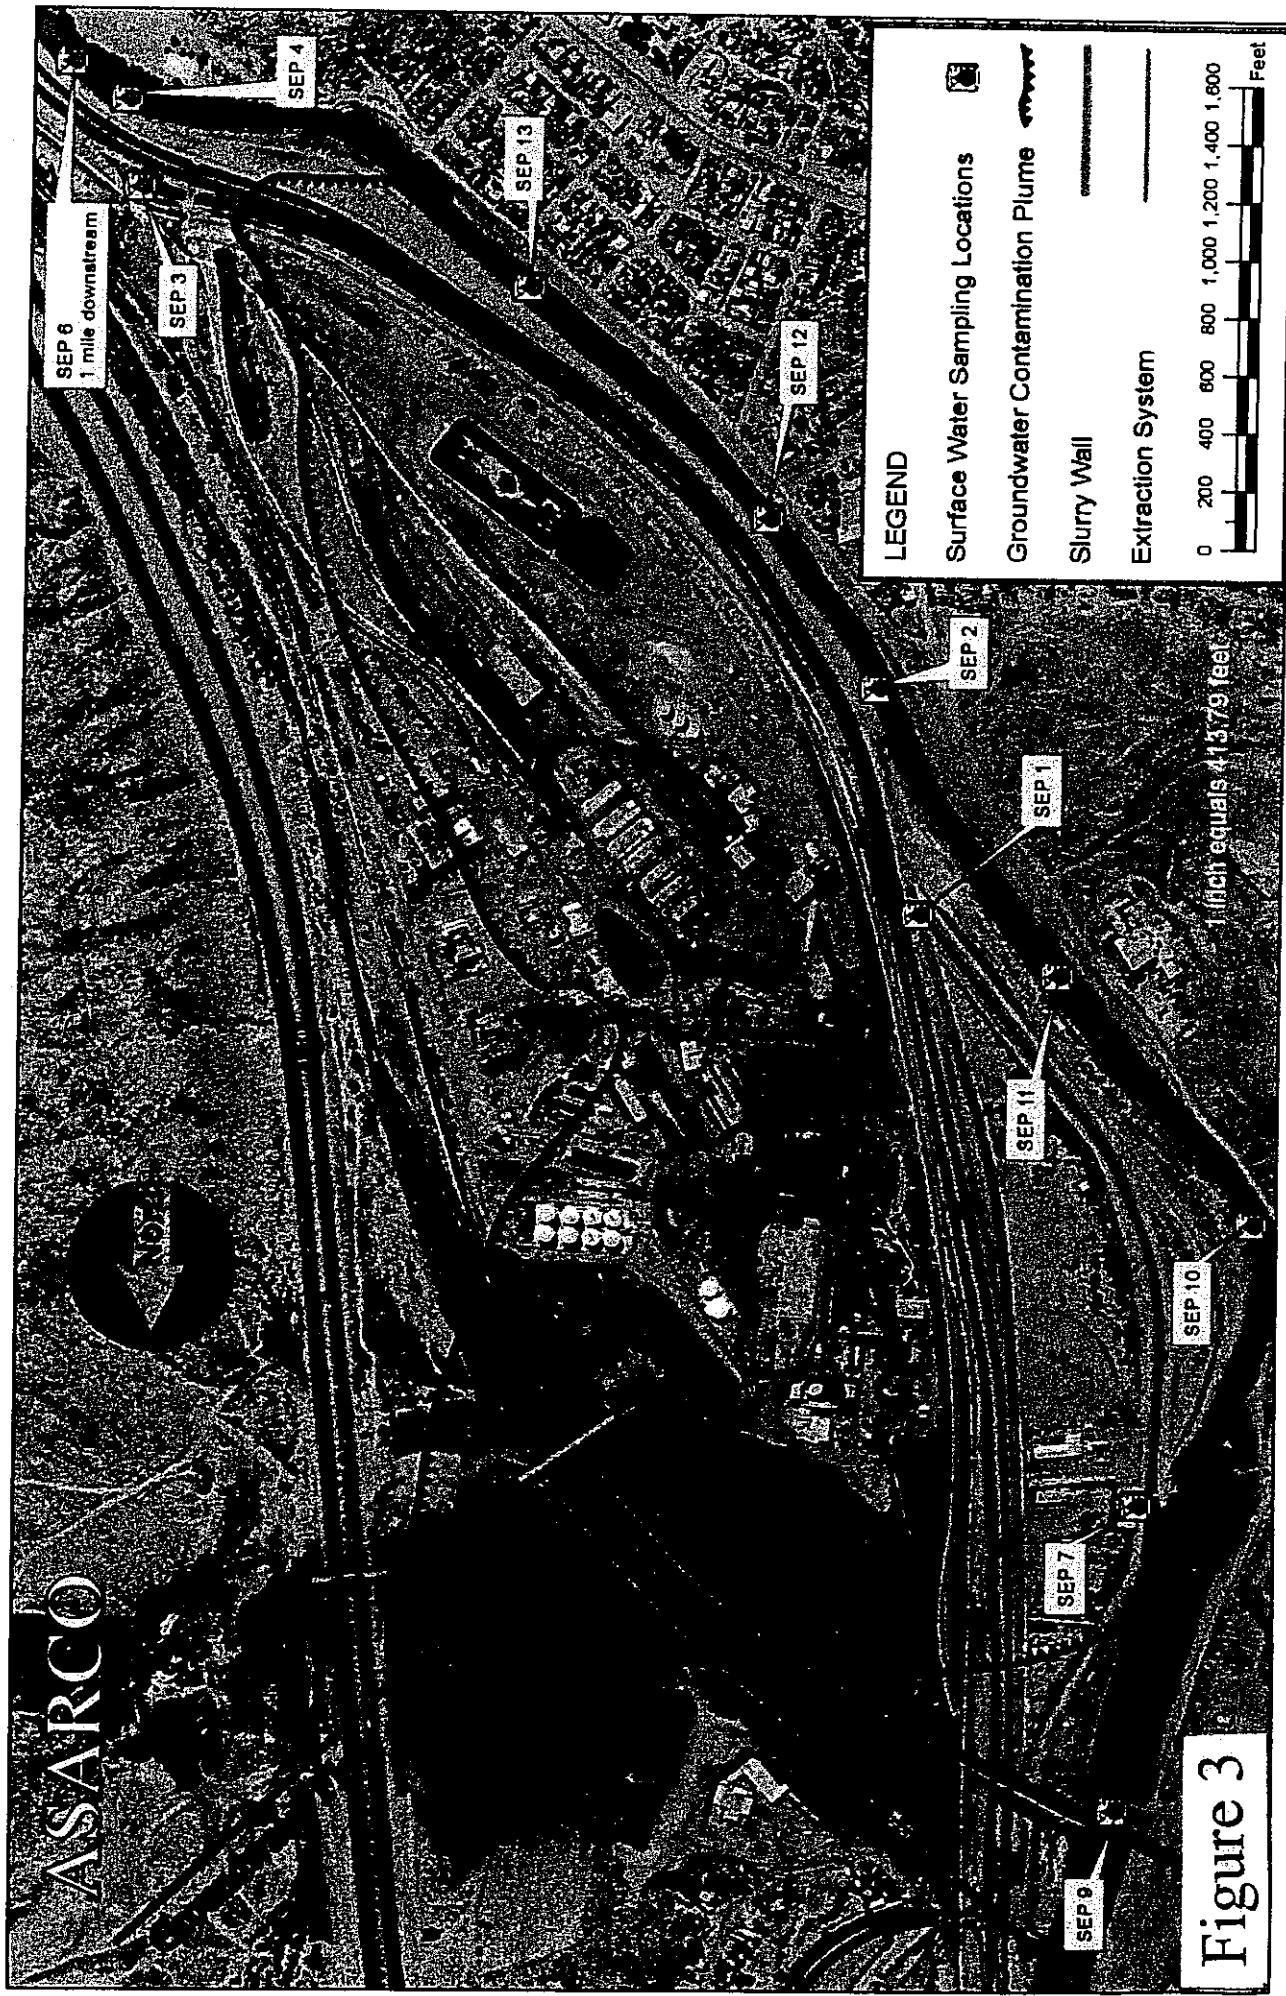
add'l 60 acres of paving

Additional asphalt paving is needed to cover waste and/or the soil with elevated metals to prevent direct contact, mitigate waste dust particles from blowing offsite, and prevent contaminated storm water runoff. The current construction specifications for the ASARCO plant consists of 1.5" Type C asphalt and 6" cold mix and cold laid asphalt material on top of 6" crushed slag as road base material. ASARCO estimated a \$2 million cost to complete the paving of the additional 16 acres of paving, which was required in the TCEQ's May 20, 2005 letter. Based on the 2005 ASARCO cost estimate, the unit cost is \$125,000 per acre or \$25.83 per square yard. This price is in line with the Texas Department of Transportation statewide construction average low bid unit price. The TECQ cost estimate is \$130,000 an acre with a 4% inflation adjustment.

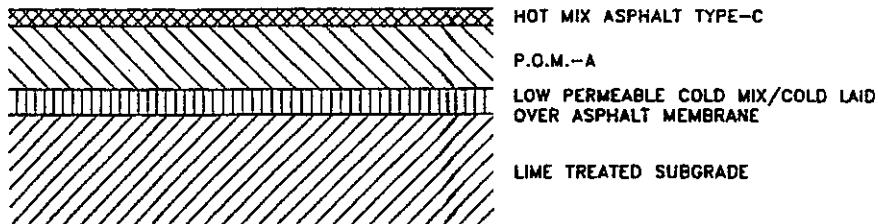
FIGURE 4

ASPHALT PAVING CROSS SECTION  
(Provided by ASARCO EL Paso Plant)

LAYERED THICKNESS (INCHES)	$s_{cf}$	$s_n$
HOT MIX ASPHALTIC CONCRETE TYPE-C	1.5	0.44	0.66
P.O.M.-A COLD MIX/COLD LAID	4.0	(ASSUMED) 0.30	1.20
LOW PERMEABLE COLD MIX/COLD LAID OVER ASPHALT MEMBRANE	2.0	(ASSUMED) 0.28	0.56
LIME TREATED SUBGRADE (VERSABIND)	6.0	(ASSUMED) 0.14	0.84

WSN = 3.26

NOTE: GEOGRID TENSAR CAPITOL BX-1100 MAY BE USED IN PLACE OF LIME TREATED SUBGRADE.

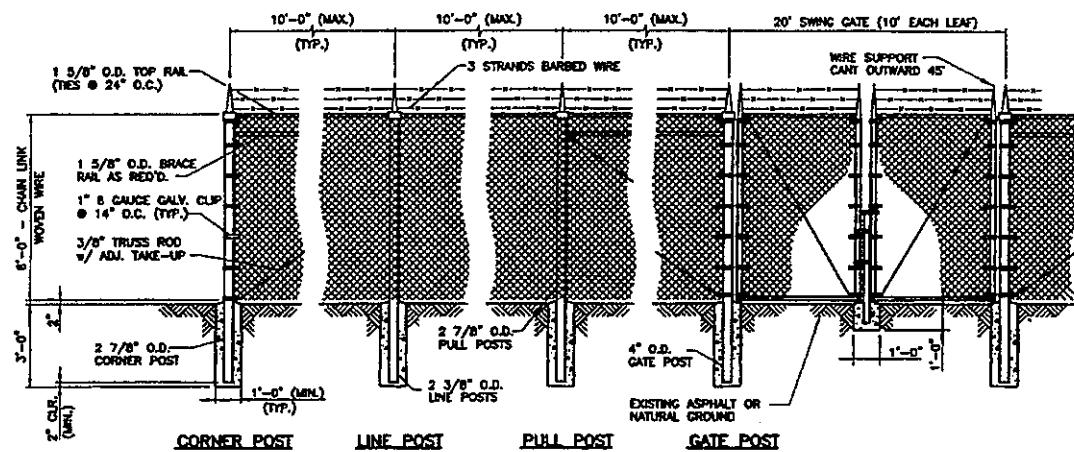
Figure 5

## CHAIN LINK FENCE CROSS SECTION

1. REFER TO SECTION 02831 FOR PRODUCT AND INSTALLATION REQUIREMENTS.

The installation of a fence is needed to enclose the northern section of the site to limit public access to the abandoned site. The \$25 a foot for a standard 6-foot chain link fence is based on the contract price from the Texas Commission on Environmental Quality "Remedial Investigation and Removal Service Contract" Contract No. 582-6-49221.

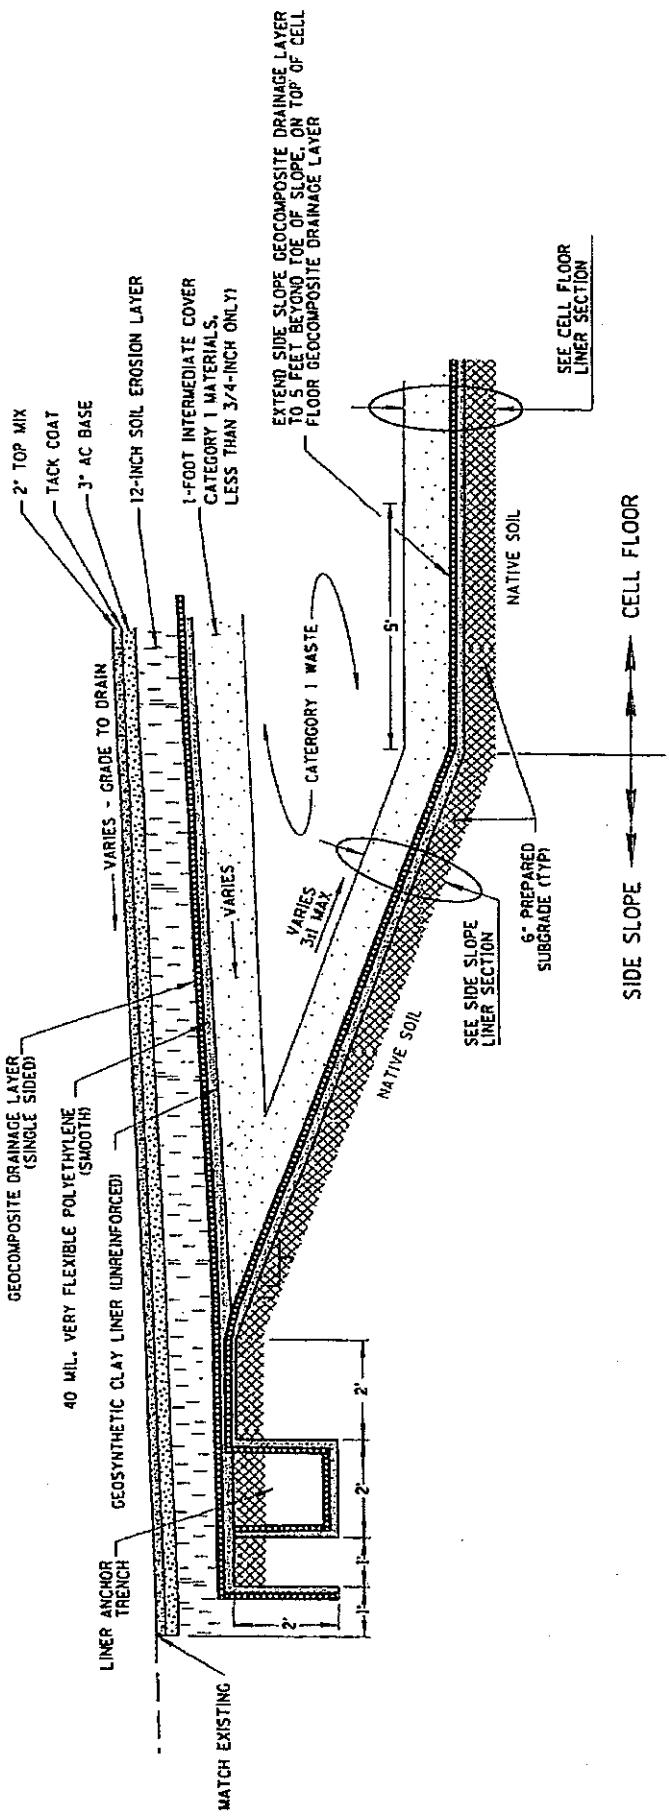
Figure 6

TYPICAL REPOSITORY CELL LINER DESIGN

As part of the waste management strategy, an additional waste repository cell will need to be constructed to accommodate material. The cost estimate for the design and construction of repository cell 4 is based on the cell dimensions of approximately 500 feet by 500 feet and 33 feet high to accommodate the 303,000 cubic yards of material. The cell floor is comprised of a layer of a geosynthetic clay liner (GCL), High Density Polyethylene (HDPE) geomembrane and a geocomposite drainage layer. After the waste material is placed into the repository cell, a cell cover is constructed. The cover is comprised of asphalt, soil, GCL, flexible polyethylene material, and a geocomposite drainage layer underneath the asphalt. The unit price of installing the cell floor and cell cover is approximately \$2.00 per square foot. A unit price of \$7.00 per square foot was used which includes design, site preparation and installation.

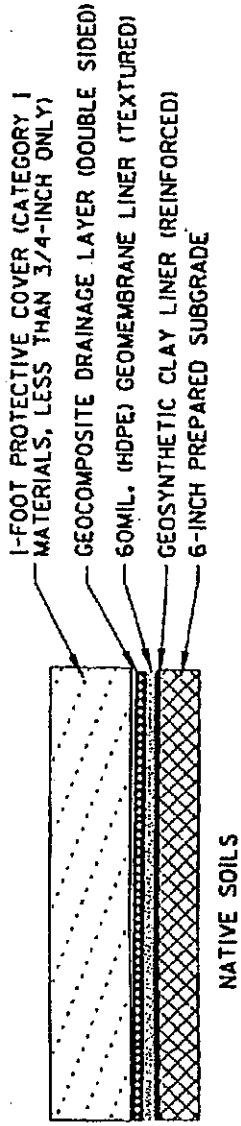
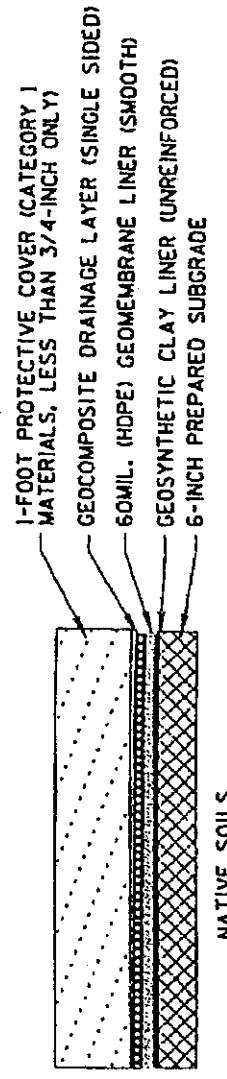
Figure 7

TYPICAL REPOSITORY CELL LINER CROSS SECTION

TYPICAL LINER  
SECTION (SIDE SLOPE)

TYPICAL LINER  
SECTION (CELL FLOOR)

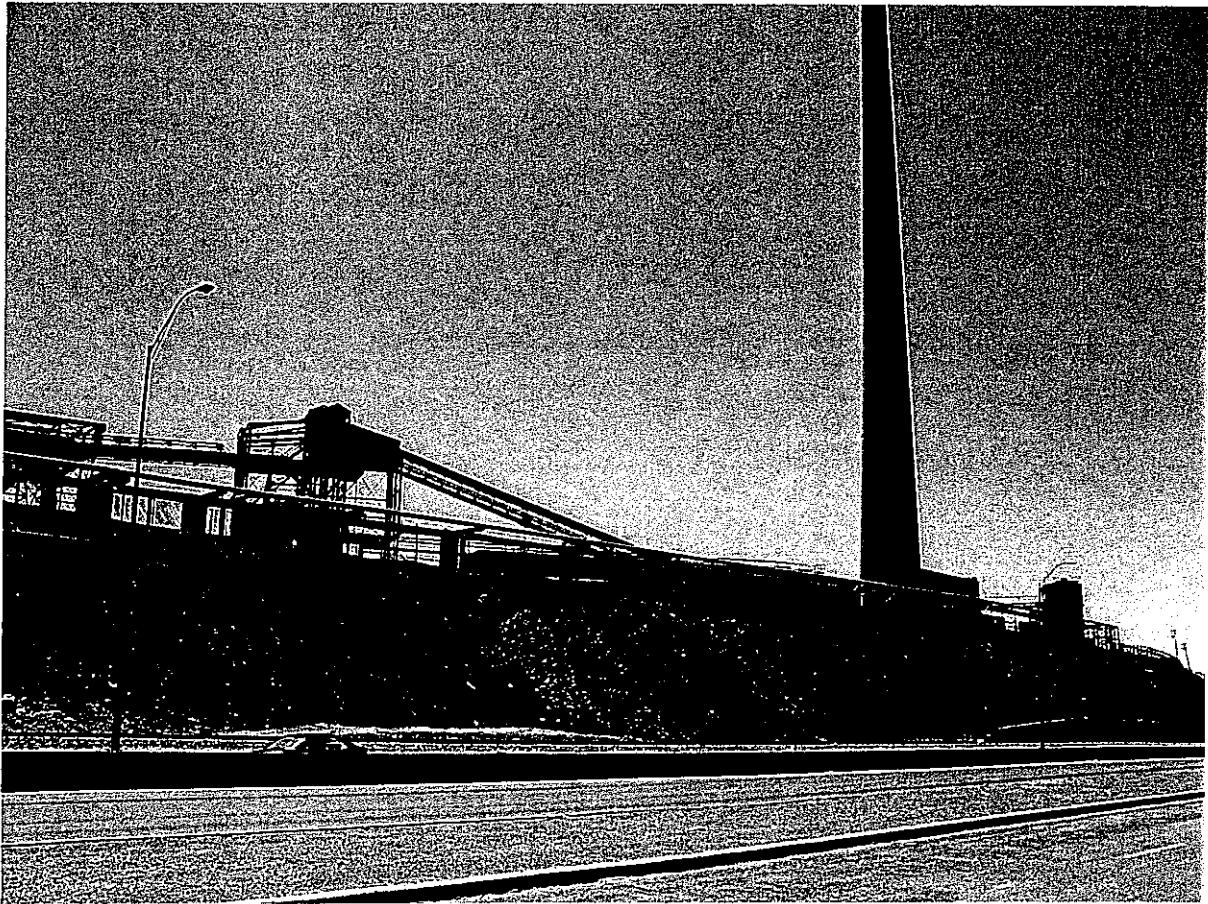
Looking Southeast at northern section of the ASARCO Smelter along Paisano Drive.

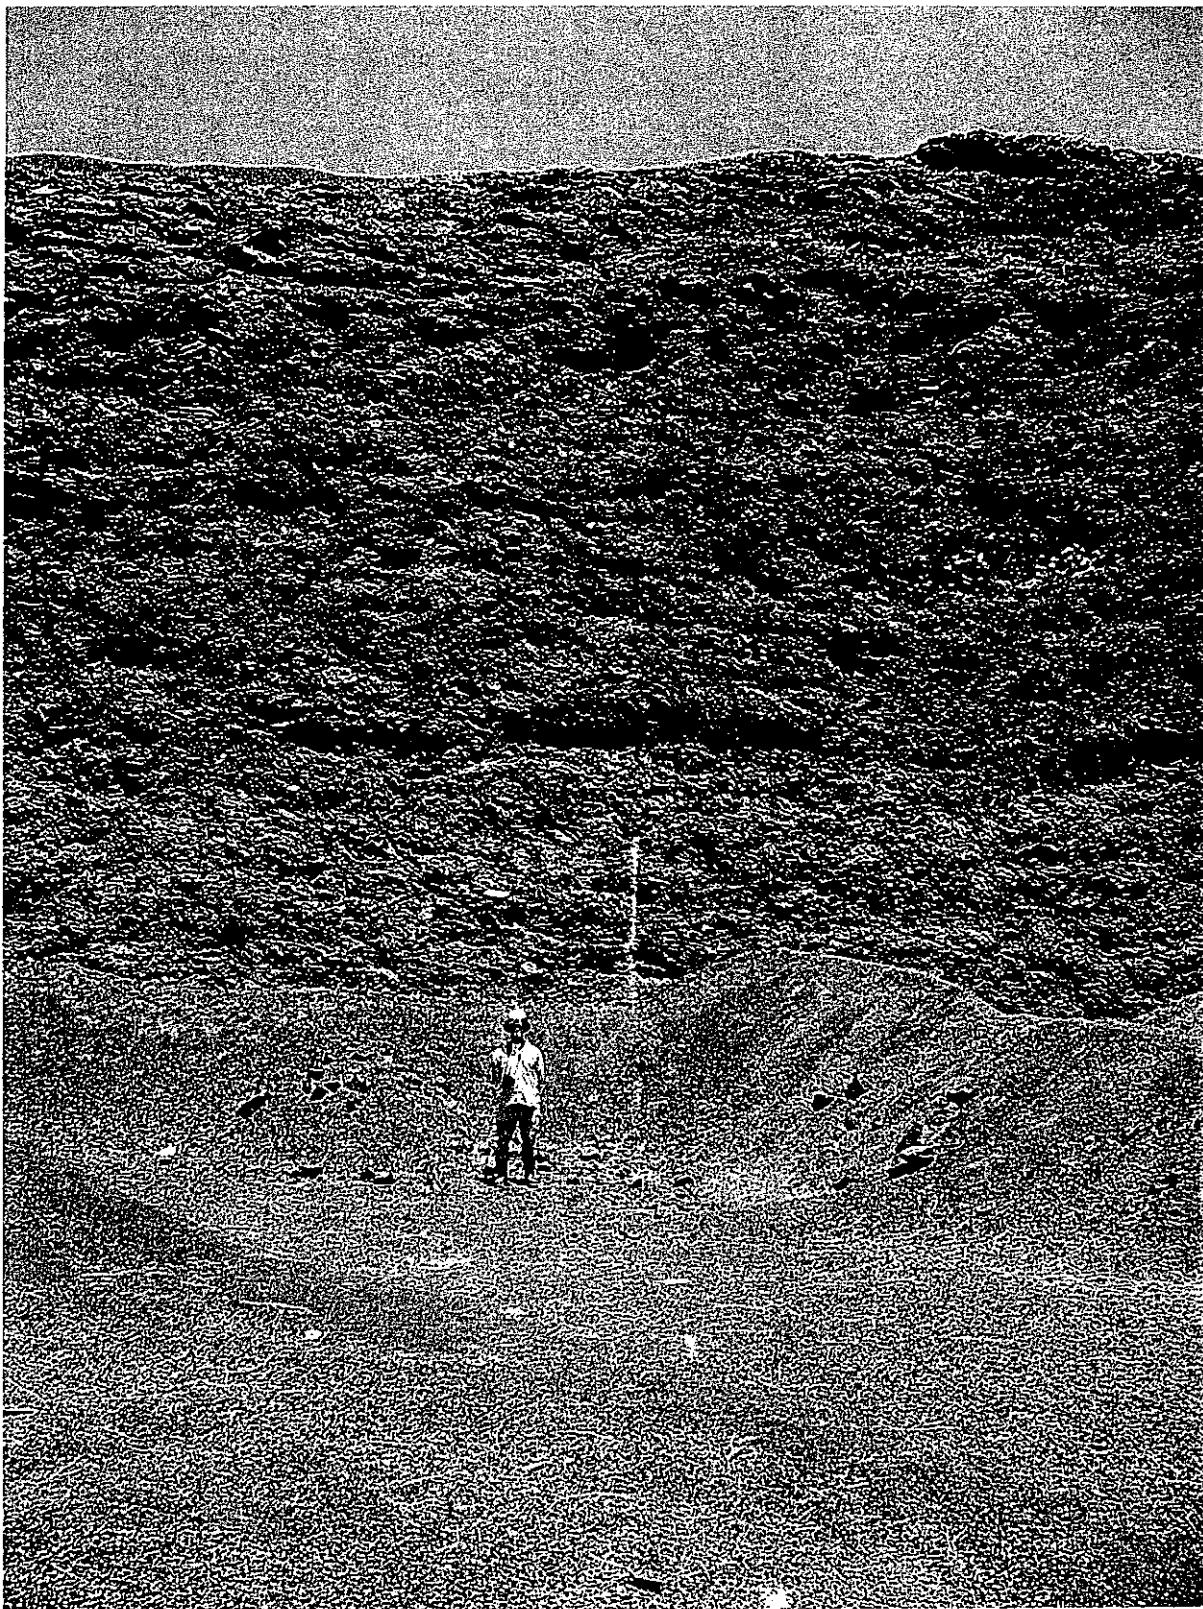
2. Looking east at exposed slag in northern section of the ASARCO smelter.

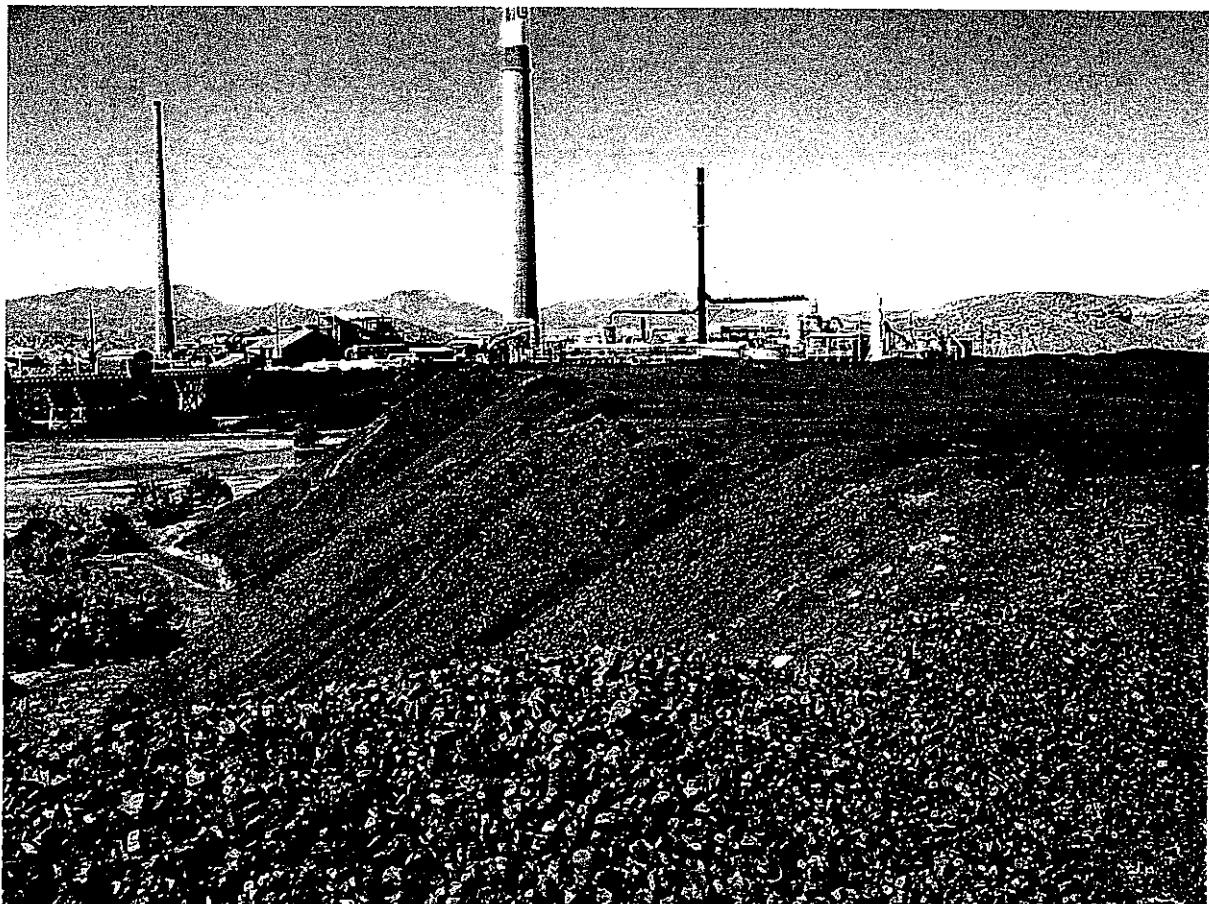
3. Looking southwest at minus 50 slag/dust and fines pile in foreground and the ASARCO smelter in background.
